**HORSBURGH & SCOTT**

## **'Sentry' Solutions**

Problem/Solution Cost/Benefit 'Case' study;

√ Grind, Regrind Mills: Multi-Mill Complex interactive damage.

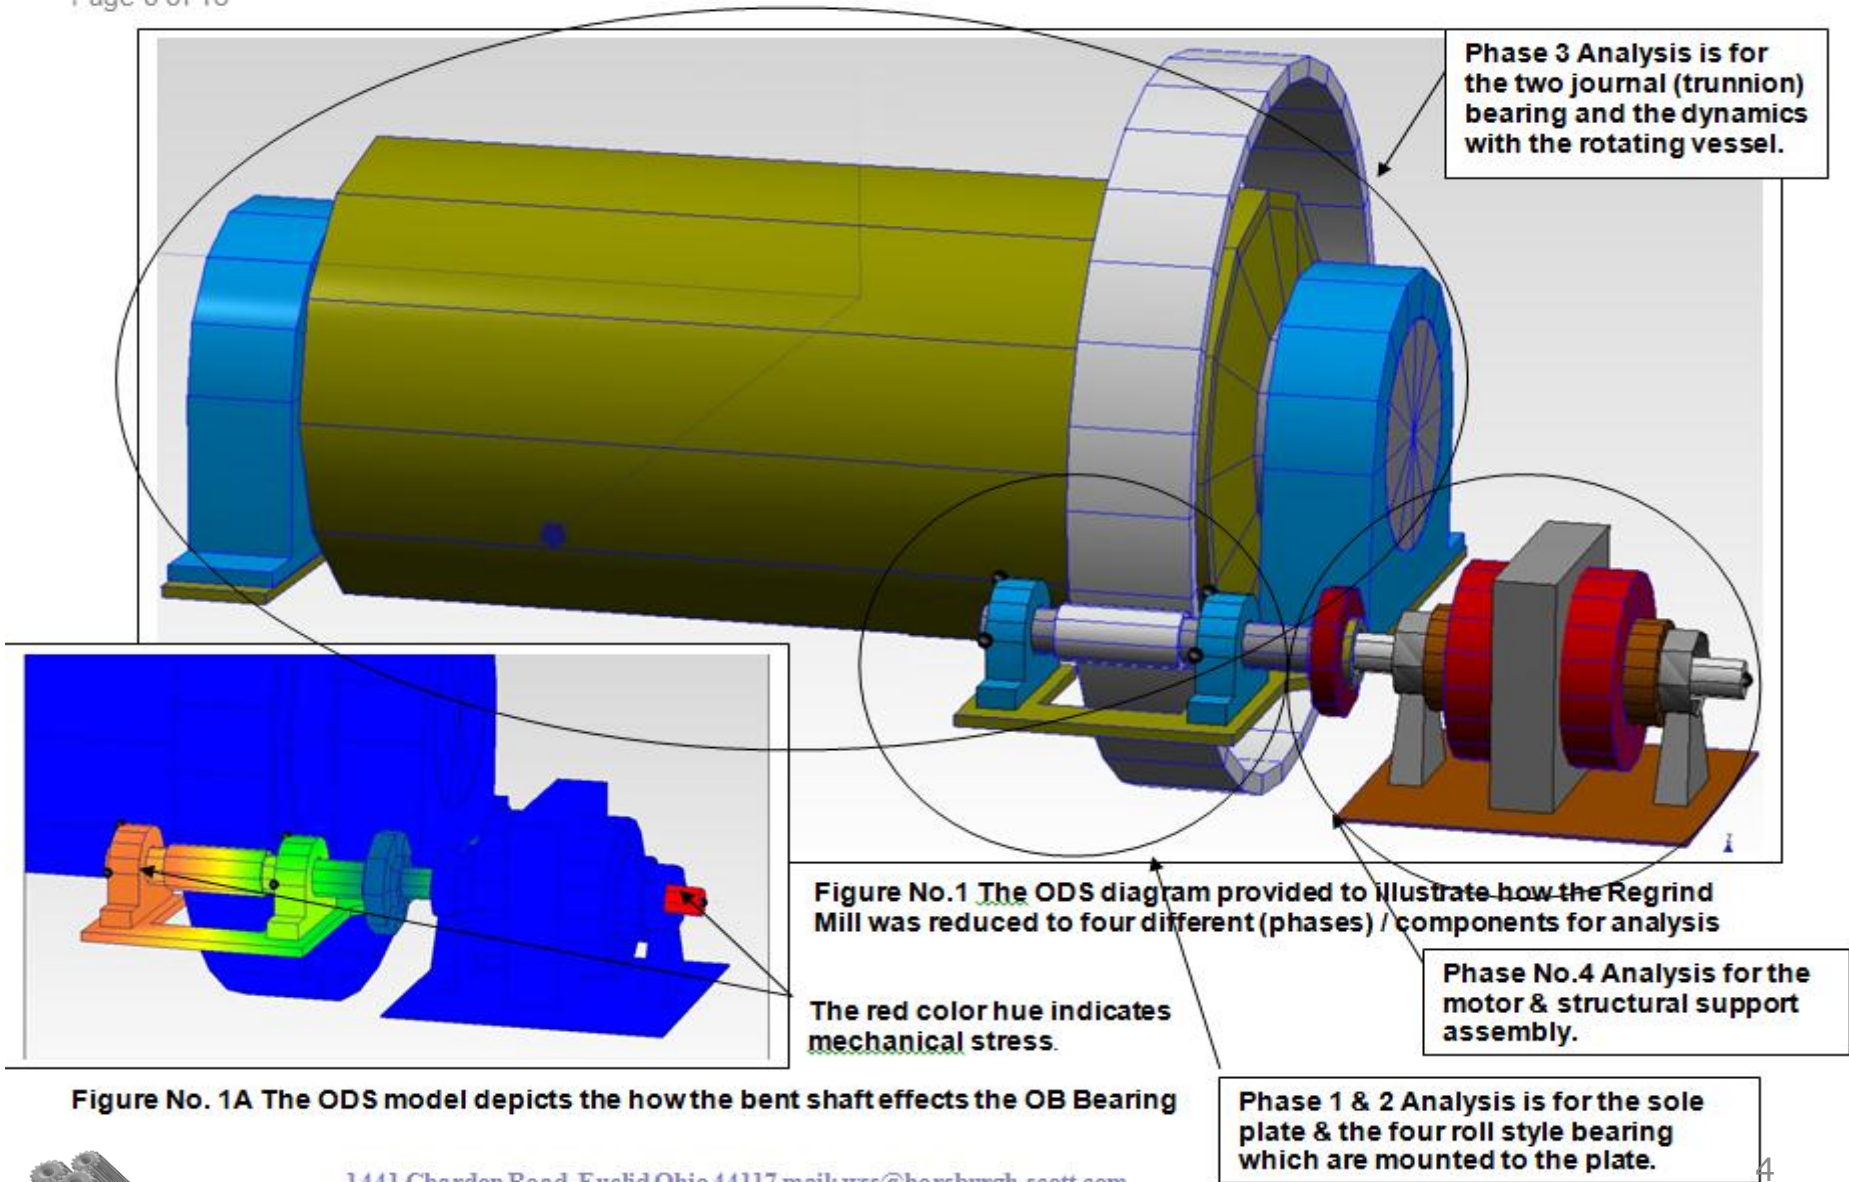
“Snapshot” from 3-D “Movie” Animation provided insight to Forces.

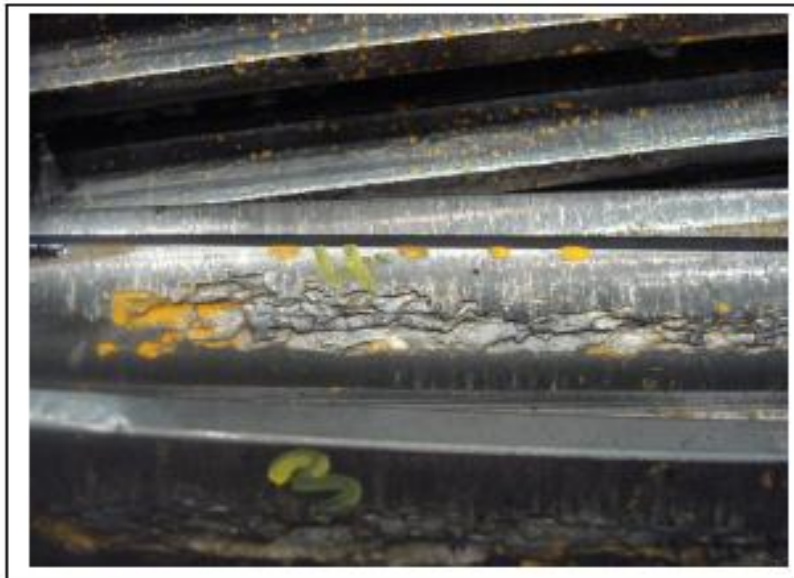
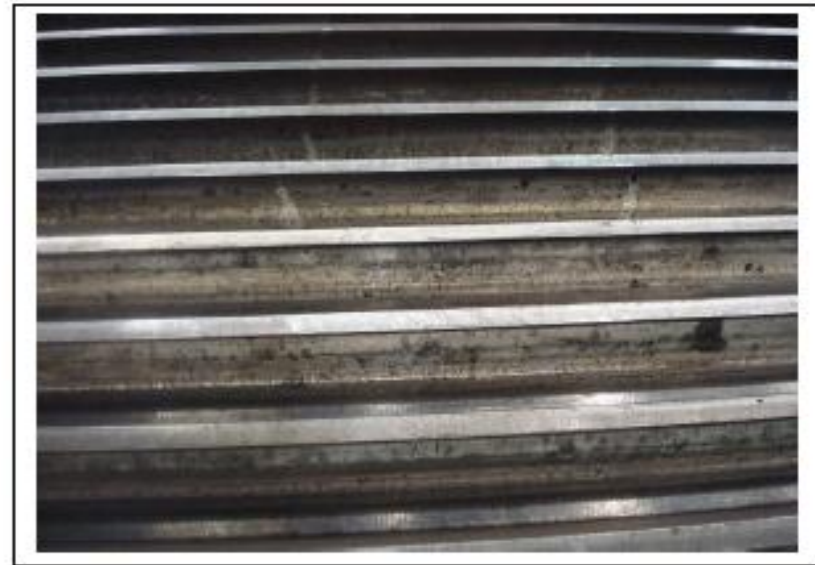
**Figure 1: Pinion teeth in comparison the Ring Gear teeth**

The Pinion was found to be in such a condition that catastrophic failure is imminent due to cracking and lack of existing base metal at the pitch line. The alignment of the pinion to the ring gear was such that there was approximately only 60% contact. The pinion was also found to be out of alignment with the motor shaft. Our inspection of the ring gear split line with a feeler showed a gap of between .002 -.005 between the mating halves. The backlash and root checks confirm the misalignment between the pinion and the ring gear. Florescent Mag Particle inspection has detected two minor indications on the ring gear and multiple linear indications on the pinion.

In figure 1 above the picture on the left shows the extent of damage of the pinion compared with the ring gear working flank on the right. Although a certain amount of gear mesh can be expected with the running of an old gear set the extent of the damage on the pinion seen here will certainly compromise the tooth geometry of the ring gear over time.

Solution Conclusion. 'Root' cause of vibration: Gear Alignment needed. (Note: this is one example of many solutions)
