Compared 'Before' and 'After' to ensure Corrective Action repair Success.
(Significantly lowered the vibration).

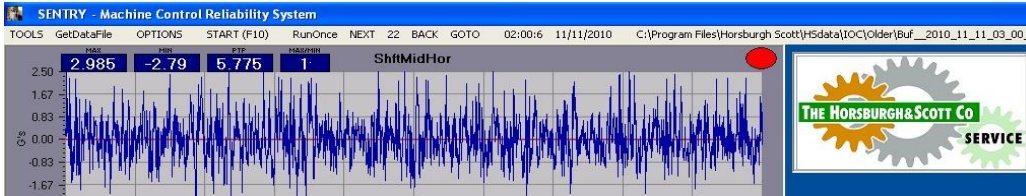
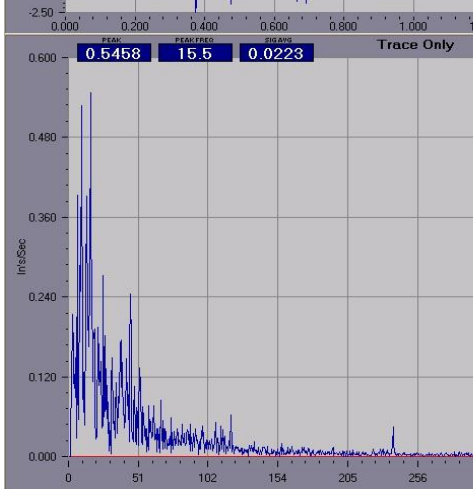
Before Rebuild:
Vibration at Pinion
Out Board Bearing
in Horizontal
Direction

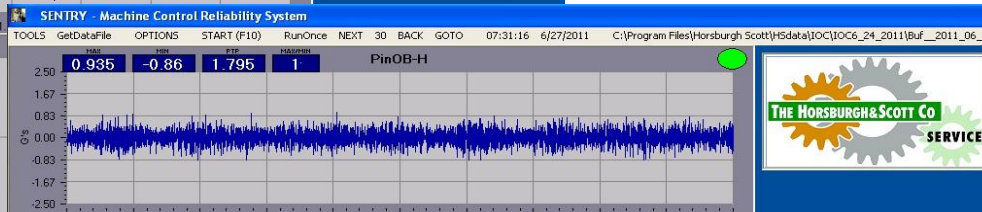
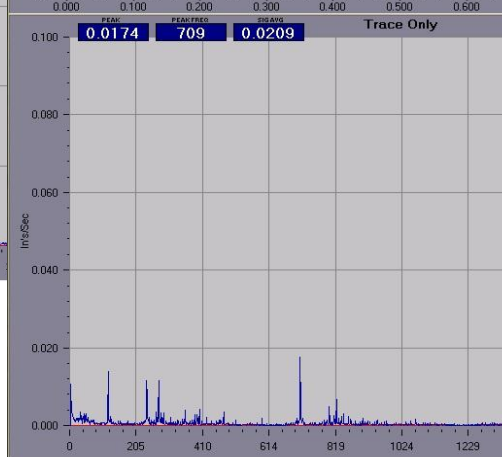
After Rebuild:
Vibration at Pinion
Out Board Bearing in
Horizontal Direction

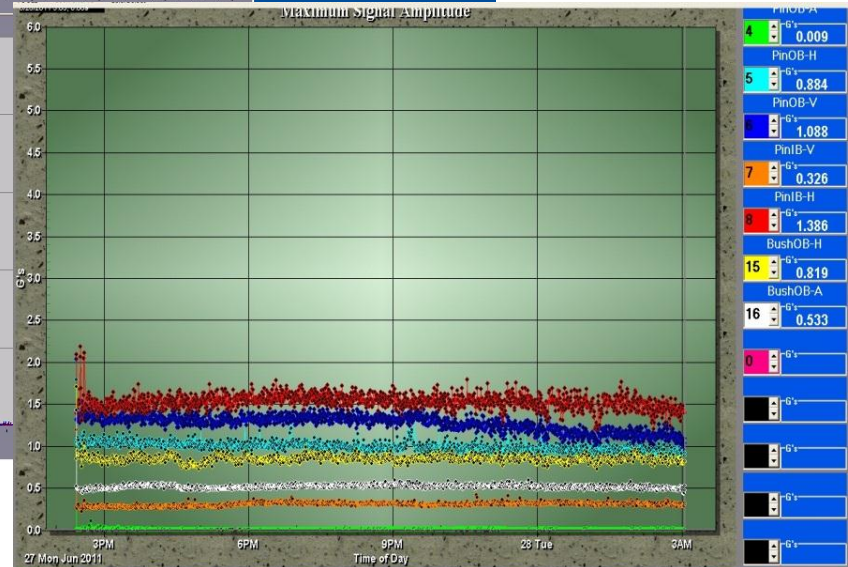
Vibration Trends AFTER Rebuild:
Low & Stable
