Compared 'Before' and 'After' to ensure Corrective Action repair Success.
(Significantly lowered the vibration).

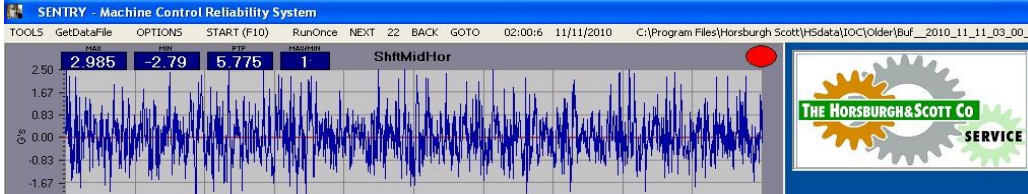
Before Rebuild:
Vibration at Pinion
Out Board Bearing
in Horizontal
Direction

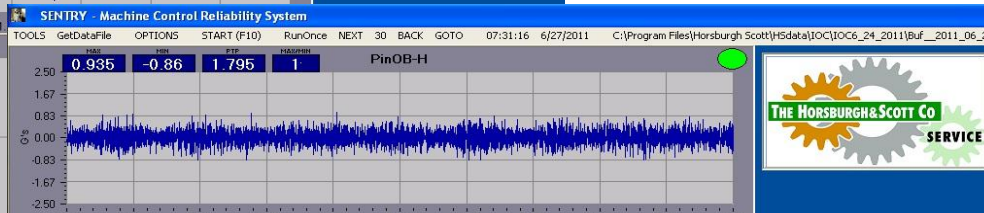
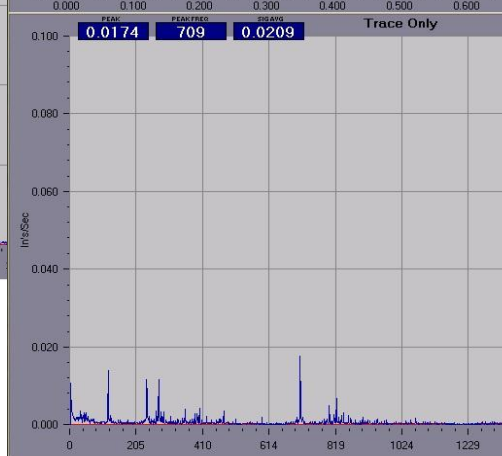
After Rebuild:
Vibration at Pinion
Out Board Bearing in
Horizontal Direction

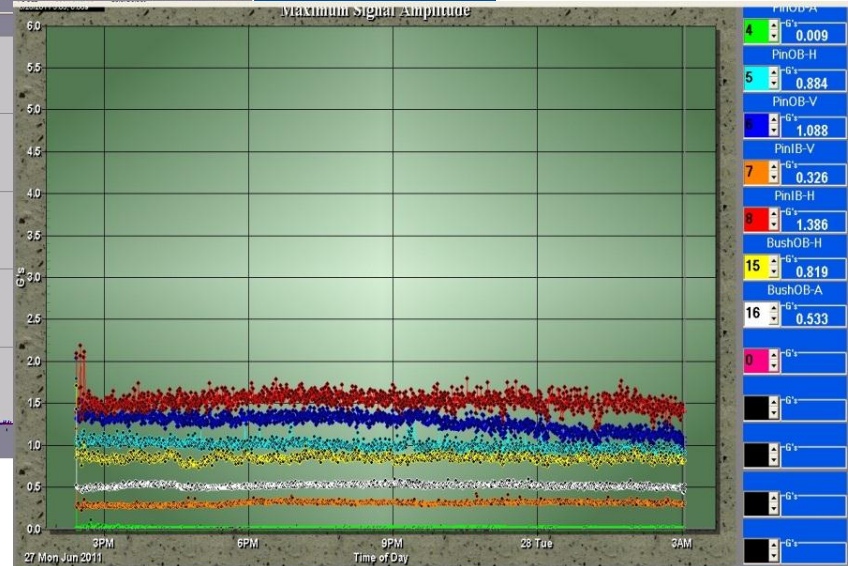
Vibration Trends AFTER Rebuild:
Low & Stable
